VOLVO L90F

Year	2011
Hours	15749
Weight	17.100 kg
Serial number	VCE0L90FT00028024
Reference	208583

INSPECTION REPORT

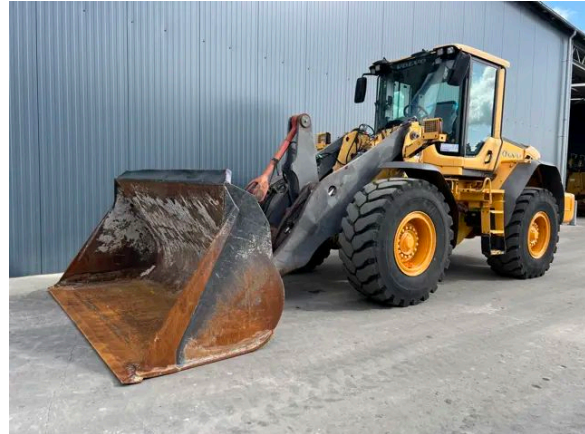
Volvo L90F, Engine and model Volvo D6E LAE3, 128 kW, EPA, CE, Air conditioning, Erops cabin, 20.5R25 Michelin , Hydraulic quick release, GP bucket with welded edge, Width of the bucket 2.88m, 3rd valve, Complete steering wheel, Autoshift, Backup camera, Backup alarm, Weight load indicator available but not tested, Cental lubrication available but not tested, Beacon, AM/ FM radio, In very good and clean condition.
