VOLVO L60E

Year	2004
Hours	16746
Weight	13.000 kg
Serial number	L60EV1374
Reference	208857

INSPECTION REPORT

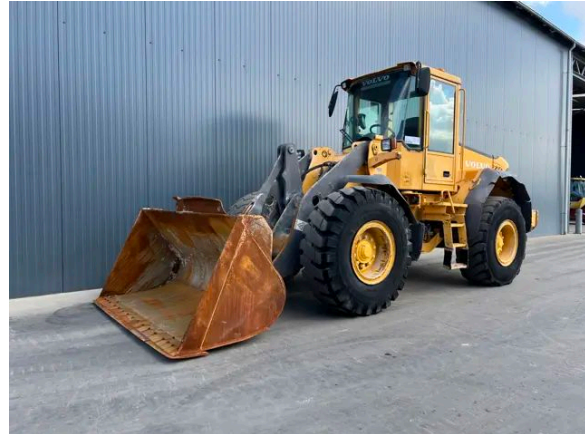
Volvo L60E, Engine and model Volvo D6D LCE2, 90 kW, EPA, Air conditioning, Erops cabin, 20.5R25, GP bucket with bolt on edge, Width of the bucket 2.50m, Complete steering wheel, Autoshift, Backup alarm, Weight load indicator available but not tested, Beacon, In good and clean condition.
